Preface

This book has been written in memory of those whose lives have been lost to the sea. We name it shortly «The Kerch book».

INTRODUCTION

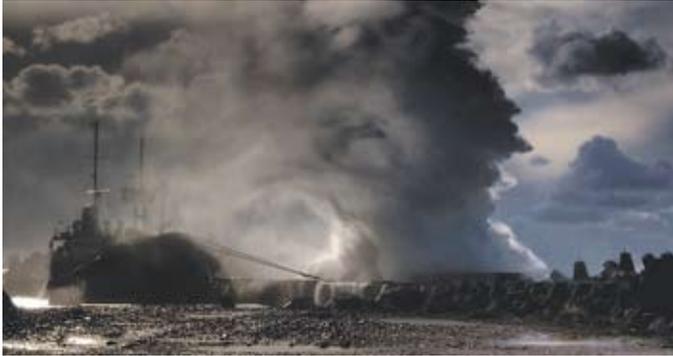
Photo: The storm on 11th of November, 2007, <http://englishrussia.com/index.php/2007/11/13/storm-hdr/>

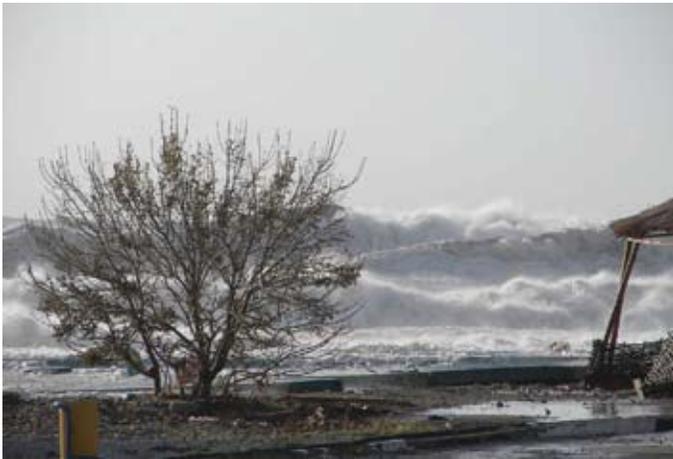
Photo: The high waves nearby Novorossiysk on 11th November 2007, by *Alexander Kuznetsov*.

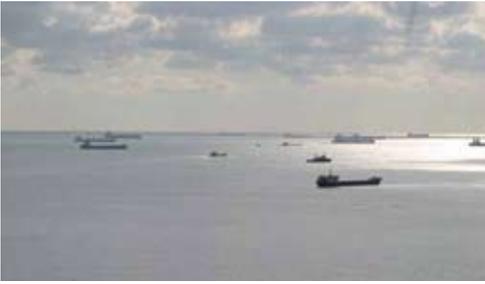
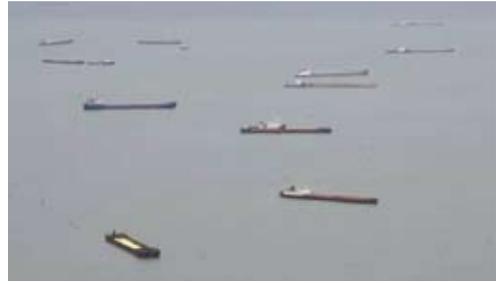
Photo: Berths and a queue of ships at anchorage in the southern part of the Kerch Strait (Booklet, 2009).

²Transshipment areas (Fig. 2) are located in the in shallow waters of the Kerch Strait Southern part without a natural shelter from storms. When ships lie at anchor in the Southern area of the Kerch Strait, as well as at the berth with the coordinates 45°06'N, 36°33'E, they are positioned about 15 miles away from the place of refuge (the Northern area of the Kerch Strait which is well protected from the Southern waves by the Tuzla Island and Chushka Spit, being considered as the place of refuge). The berths in the Southern area of the Kerch Strait do not provide protection from the waves coming from the hazardous Southern directions especially.

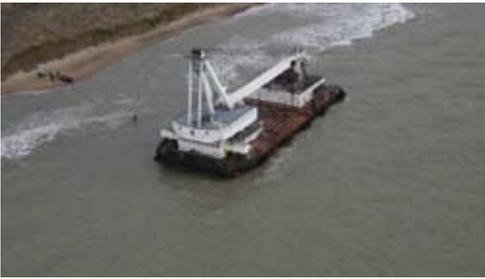
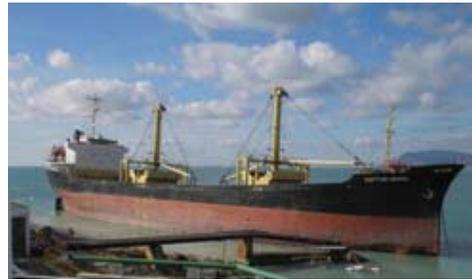
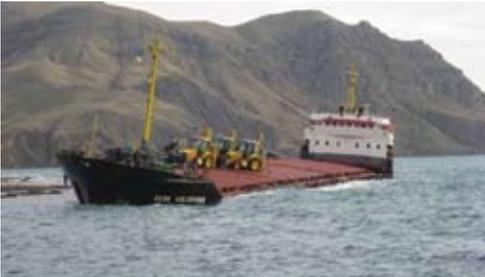
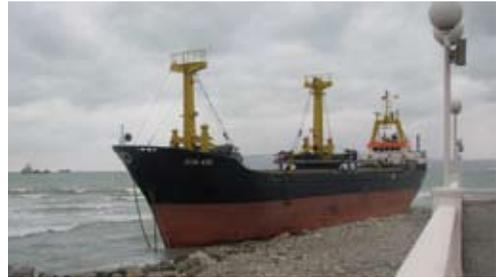
Photo: The *Sevastopoles* floating crane in the Kerch Strait, the *Captain Ismael* dry cargo ship stranded in Novorossiysk, the *Vera Voloshina* cargo ship aground in Crimea and *Ziya Koc* dry cargo ship in Novorossiysk, photo re-drawn from Booklet, 2009, and by *Alexander Kuznetsov*.

The *Vologoneft-139* motor tanker and the *Volnogorsk*, *Nahichevan* and *Kovel* dry-cargo motor vessels anchored in the Kerch Strait were virtually torn apart by the storm. The *Vologoneft-139* boat broke into-two and its bow sank in vicinity of the main ship channel of the Strait at the 10 m depth. The stern section drifted by wind to north and touch the ground at 45°15'5 N and 36°31'8 E. From this tanker leaked about 1300 tons of heavy fuel⁵, and it happened approximately five km to the West from the Tuzla Spit (Fig. 2). An immediate attempt to prevent oil from leaking from the wreck by using

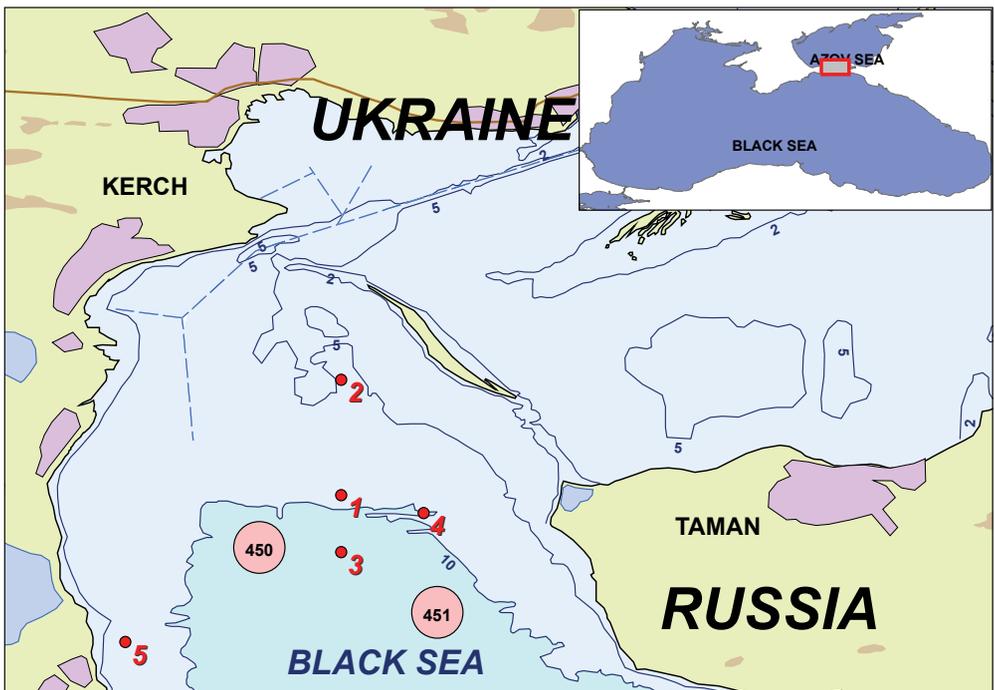
The other motor vessels of *Volnogorsk* (loaded with 2437 t of granulated sulfur), *Nahichevan* (2366 t) and *Kovel* (1923 t) did not sink immediately, but drifted towards the coast of Ukraine to the South from the Tuzla Island. It was later reported that the sulfur granulates discharged to the sea floor had been leaked from the *Kovel* motor vessel. The m/v *Volnogorsk* sank at 45°11'6 N and 36°31'8 E at the depth of 11 m. All the crewmembers (8 persons) left on the life raft. The *Neptunia* sea tug (Ukraine flagged) was sent to the life raft. The *Nahichevan* motor vessel sank at 45°12'0 N and 36°33'3 E; *Kovel* sank at 45°09'1 N and 36°26'6 E (Fig. 2).

Fig. 2. Map of the areas where the ships sank in the Kerch Strait on 11 November 2007: the *Volgoneft-139* tanker bow (point 1) and stern (point 2; 45°15'5 N and 36°31'8 E), *Volnogorsk* (3; 45°11'6 N and 36°31'8 E), *Nahichevan* (4; 45°12'0 N and 36°33'3 E) and *Kovel* (5; 45°09'1 N and 36°26'6 E). Transshipment areas Nos 450 and 451 are marked in red.

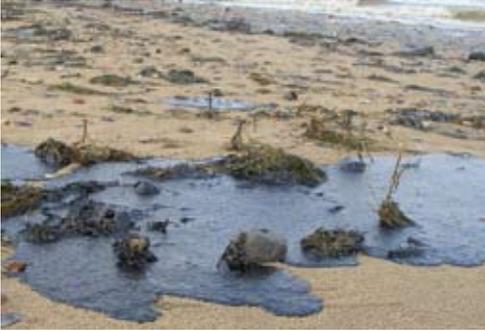
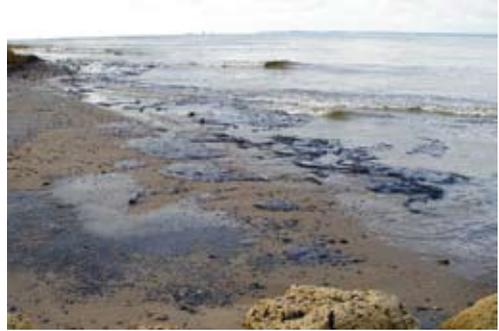
Photo: November 12, 2007, oil patches on the Tuzla Spit, <http://www.flickr.com/photos/>.

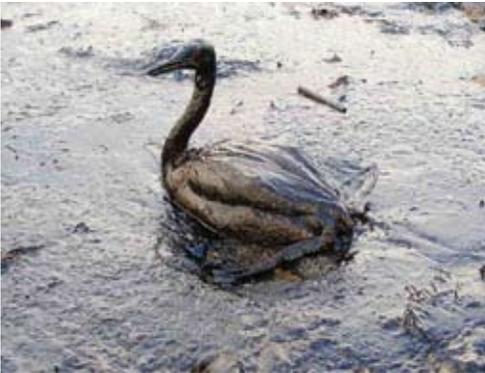
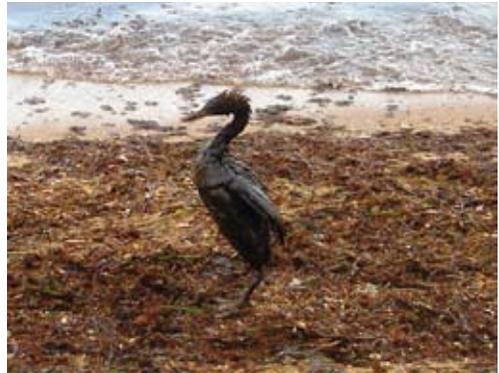
Photos: A birds stained with fuel oil sits at the shore near Russia's port Caucasus (published by Reuters: Mr. Alexander Natruskin), photo of Igor Golubekov (NGO: Saving Taman, <http://www.flickr.com/photos/>).

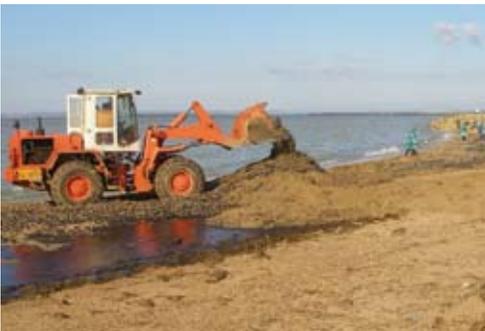
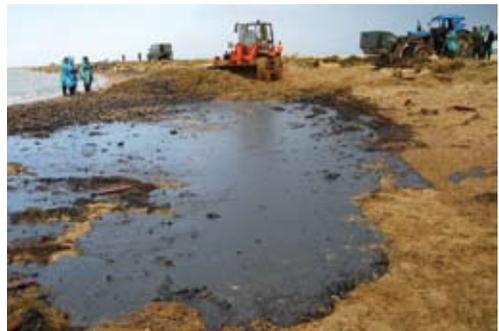
Photo: Techniques were used for the clean-up operations on the coast, by Igor Golubekov (NGO: Saving Taman), November 12, 2007, on Tuzla Spit, <http://www.flickr.com/photos/>.

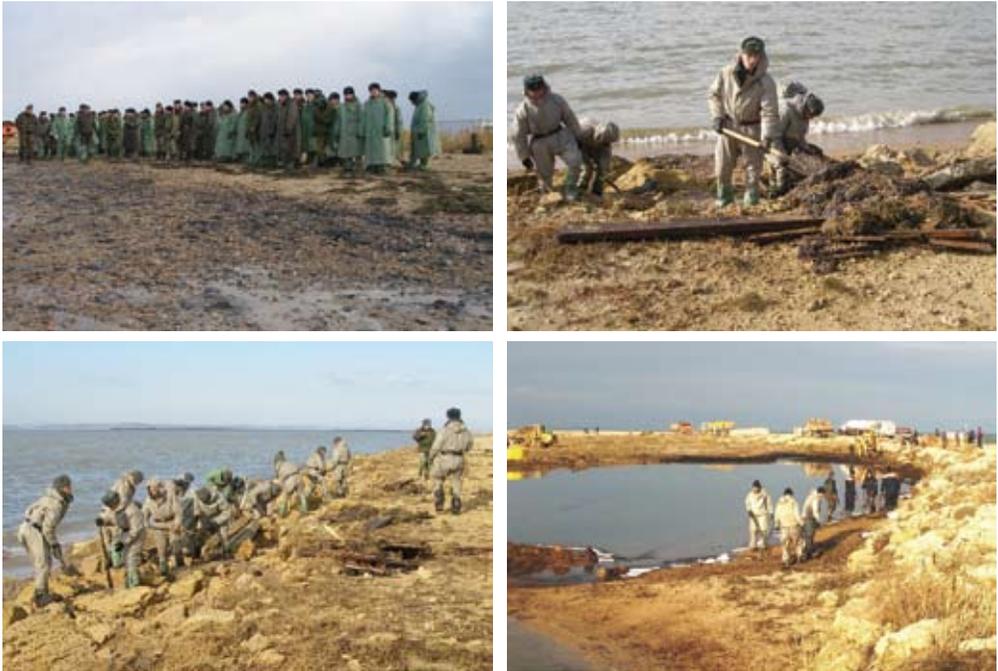
Photo: Military forces and volunteers engaged in clean-up operations on the coast, by *Igor Golubenkov* (NGO: Saving Taman), November 12, 2007, on Tuzla Spit, <http://www.flickr.com/photos/>.
